Roy Property Accessory Building

Readfield, Maine

January 19, 2023

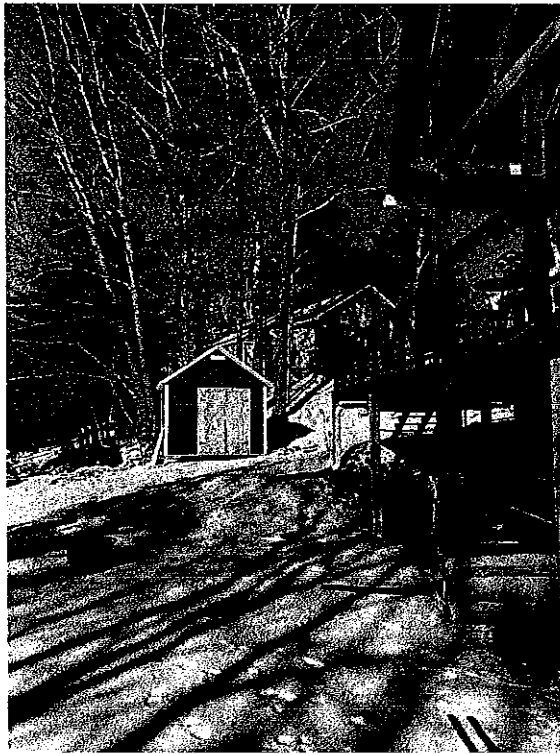
Photo 1: Looking north at the new shed.

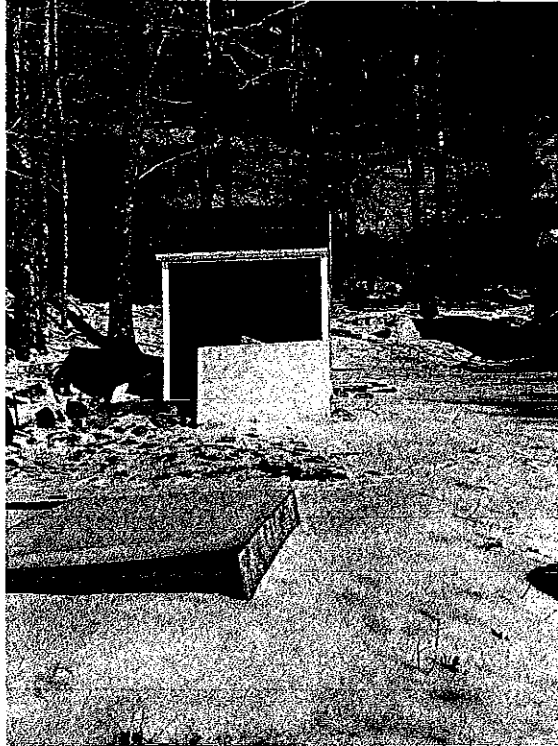
Photo 2: Components of the old shed in the foreground. Looking west.

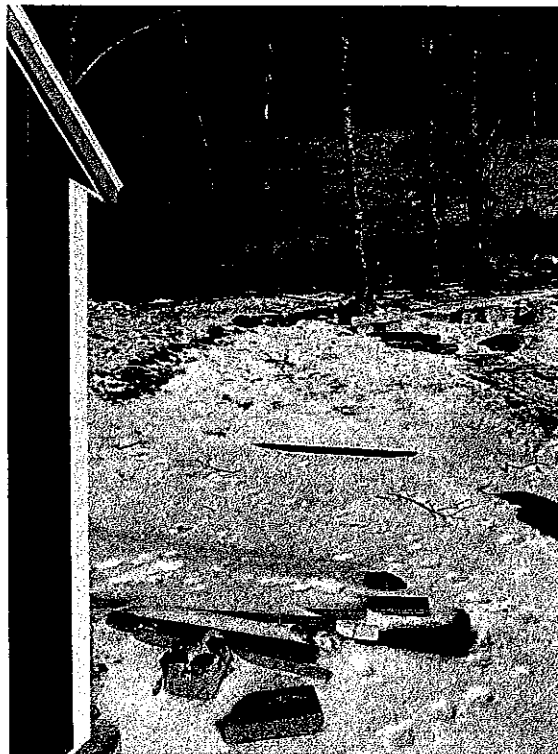
Photo 3: The area immediately behind the new shed, the proposed location to move back to the most practical extent.

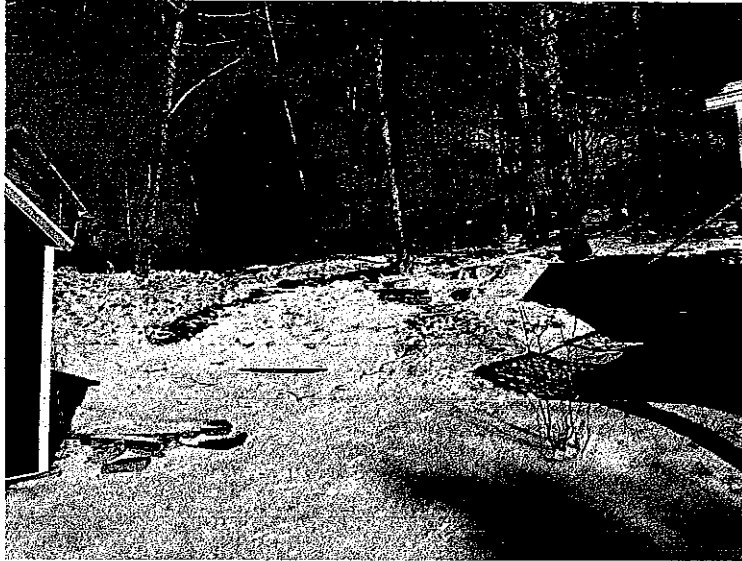
Photo 4: The piece of lumber represents 95 feet from the HWL. This is the proposed location of the back of the new shed.
