Roy Property Accessory Building

Readfield, Maine

January 19, 2023

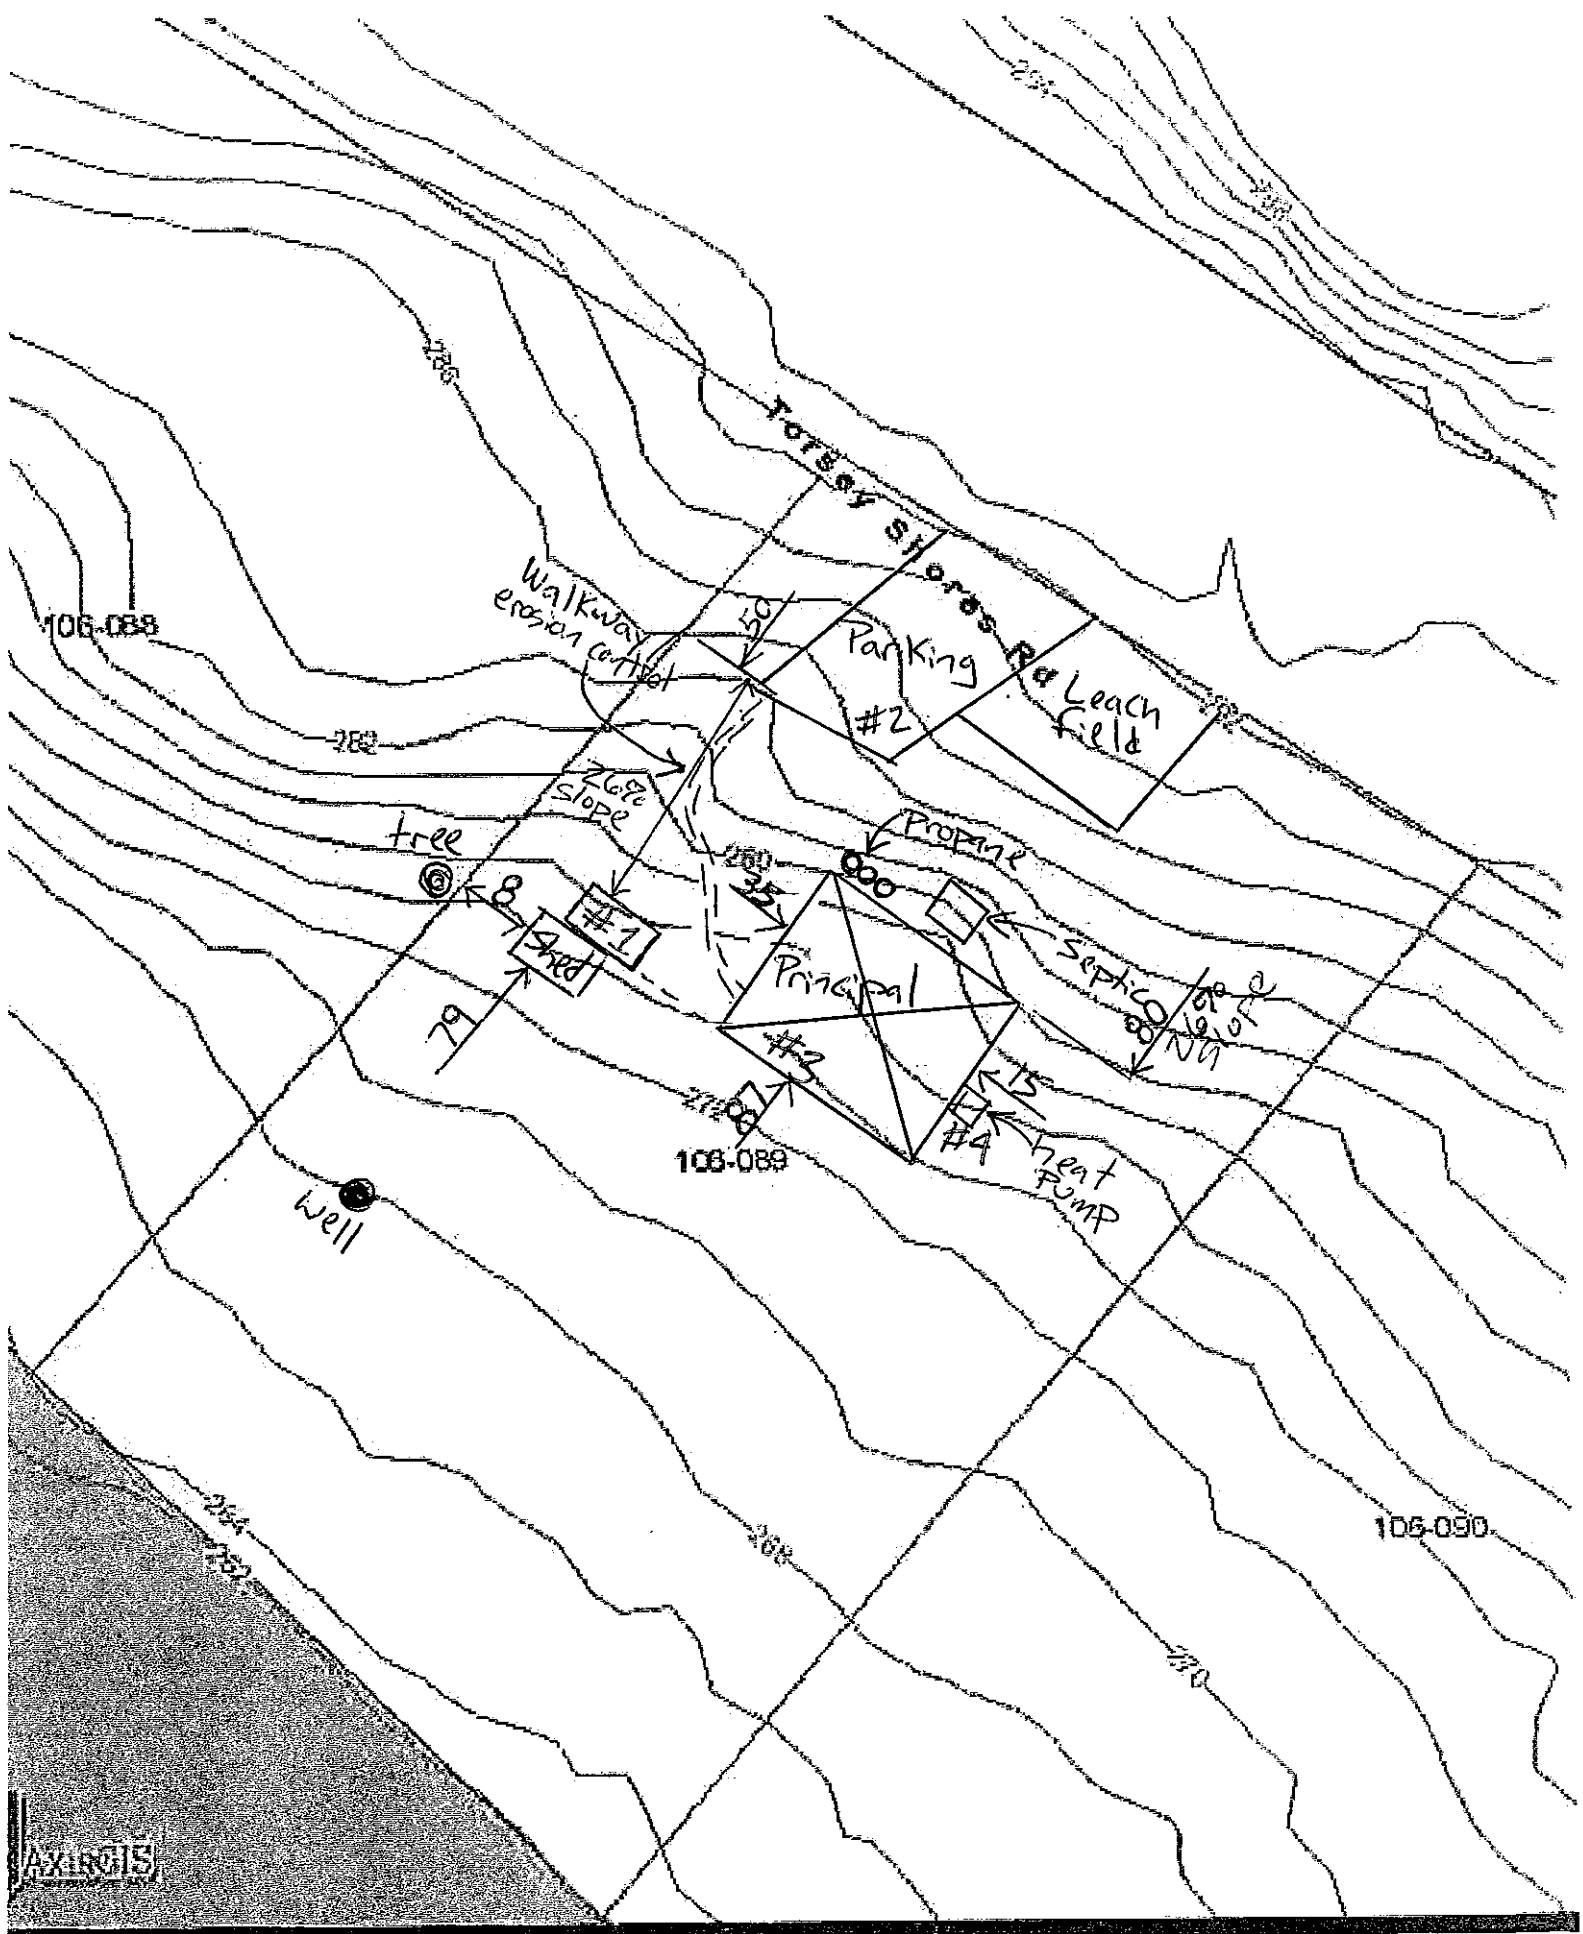
The accessory building replacement in question has been located in a non-conforming spot that is 79ft from the HWL (determined by Kings Landing Co) and 8ft from the abutting lot. This location was considered GPE, by the homeowner, with consideration of the location of the prior shed and no excavation required.

For comparison, the original shed (6x8 = 48 sq ft) location was 12" closer to the HWL & directly on the abutting property line.
